**INVESTIGATIONS ON HIGH  
TEMPERATURE CORROSION AND  
EROSION BEHAVIOUR OF PLASMA  
SPRAYED Co-BASED COMPOSITE  
COATINGS**

Thesis

**DOCTOR OF PHILOSOPHY**

**DEPARTMENT OF MECHANICAL ENGINEERING  
NATIONAL INSTITUTE OF TECHNOLOGY, KARNATAKA,  
SURATHKAL, MANGALORE - 575 025**

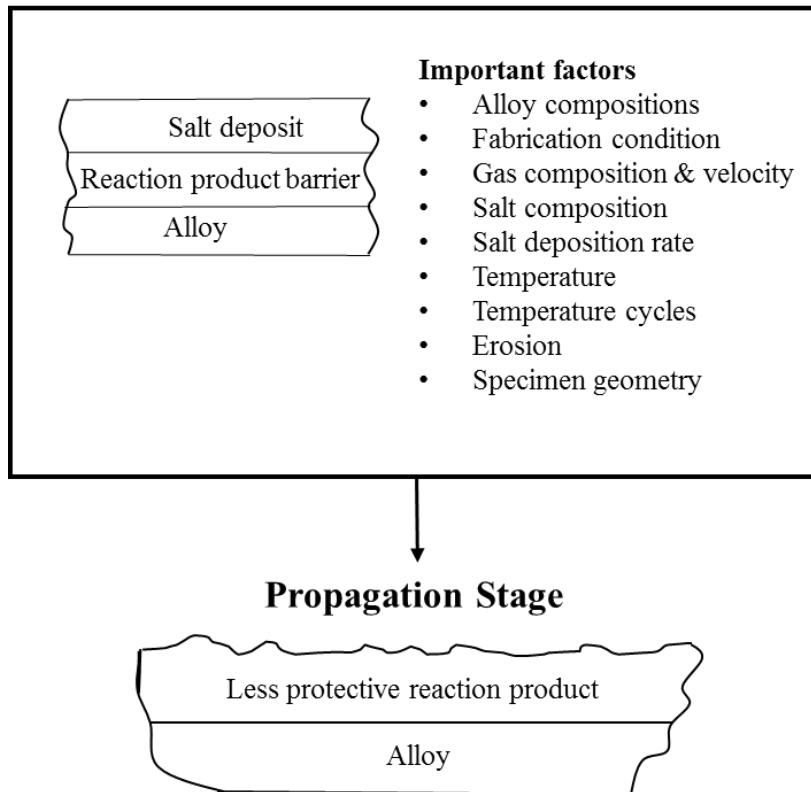
Figure 2.3 Diagram showing initiation stage and propagation stages of hot corrosion.

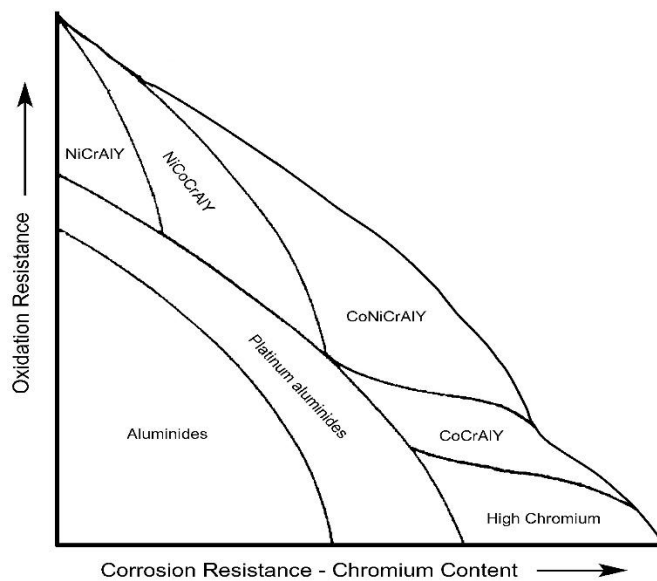
Figure 2.7 High temperature oxidation and corrosion resistance of different coating systems (Nicholls et al. 2002).

coating at 1000°C for 1000 h was investigated by D Seo et al. (2008). Interestingly CoCrAlY exhibits highest oxidation resistance with 50 times lesser parabolic rate constant ( $K_p$ ) value than NiCrAlY, since Ni element diffused from the substrate may help the CoCrAlY to be more stable. Because, CoNiCrAlY and NiCoCrAlY are the coatings which mean that they are more stable in interdiffusion than CoCrAlY and NiCrAlY. High temperature oxidation and corrosion resistance of different coating systems are illustrated in Figure 2.7.

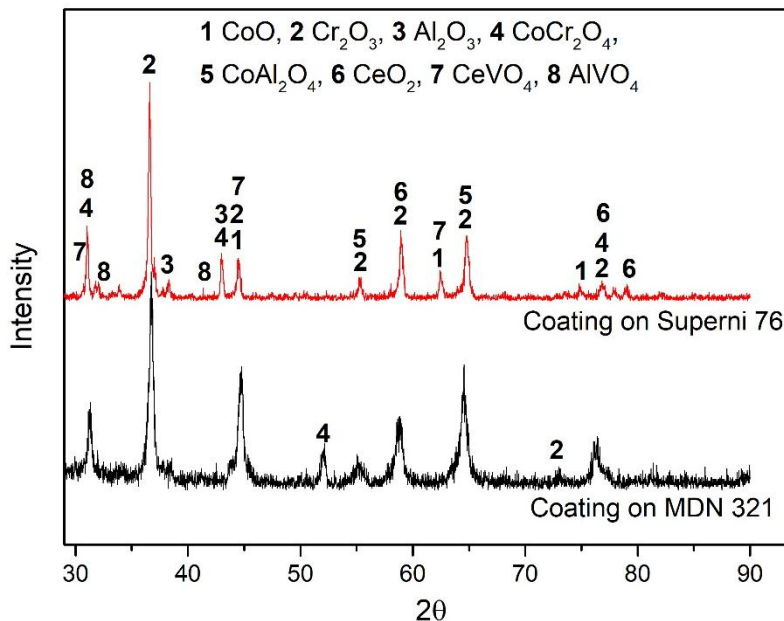
Figure 6.9 XRD patterns for CoCrAlY+CeO<sub>2</sub> coated alloys subjected to hot corrosion.

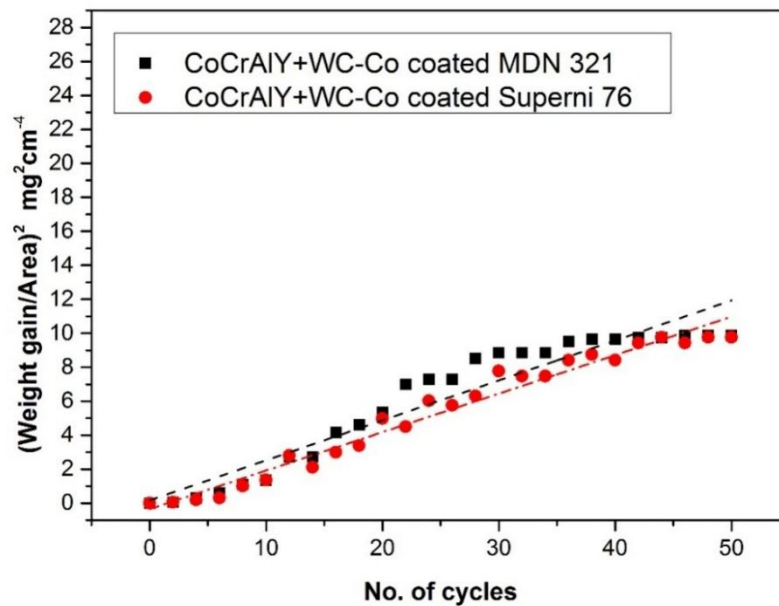
Figure 6.14  $(\text{Weight gain/area})^2$  vs. number of cycles plot of CoCrAlY+WC-Co coated alloys subjected to hot corrosion.
